Intelligent Manual Call Point Installation Guide

Part No	Product Name	Туре
SA5900-908	Intelligent Manual Call Point	Indoor
SA5900-928	Intelligent Marine Manual Call Point	Indoor
SA5900-948	Intelligent Marine Manual Call Point (SIL Approved)	Indoor
SA5900-903	Intelligent Manual Call Point (White)	Indoor
SA5900-904	Intelligent Manual Call Point (Yellow)	Indoor
SA5900-905	Intelligent Manual Call Point (Blue)	Indoor
SA5900-906	Intelligent Manual Call Point (Green)	Indoor
SA5900-907	Intelligent Manual Call Point (Orange)	Indoor

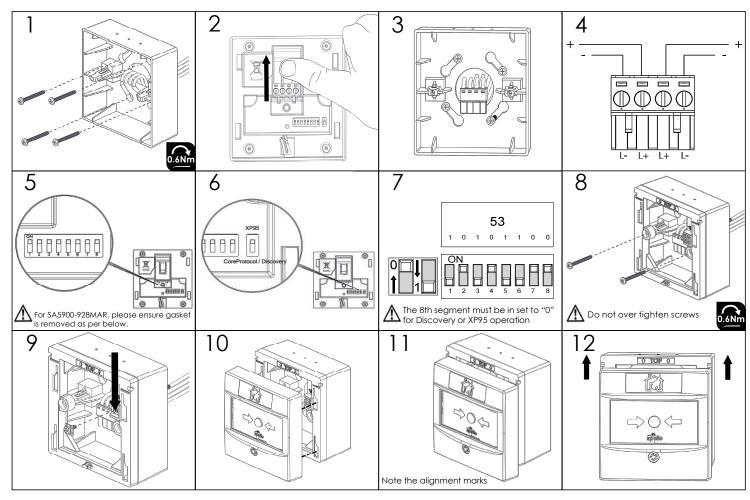
Installation

SA5900-928MAR

For maintaining IP44 rating, please take care to remove the gasket before addressing and replacing after. This step fits inbetween image 4 and 5, and is placed back on between image 7 and 8.
