### specificatii

### Structura produsului

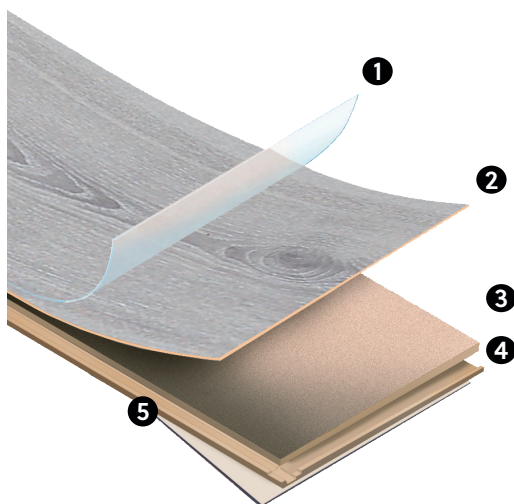
- ❶ **Strat protector** care determina rezistenta si durabilitatea pardoselii dumneavoastra
- ❷ **Hartie decorativa** pentru design
- ❸ **Un miez de fibra de densitate mare (HDF)**
- ❹ **Un strat de echilibrare** pentru a stabili și proteja miezul HDF
- ❺ **Acoperirea hidro+ rezistenta la apa**
